## Special Commission on the 1999 Texas A&M Bonfire

# **Final Report**

May 2, 2000

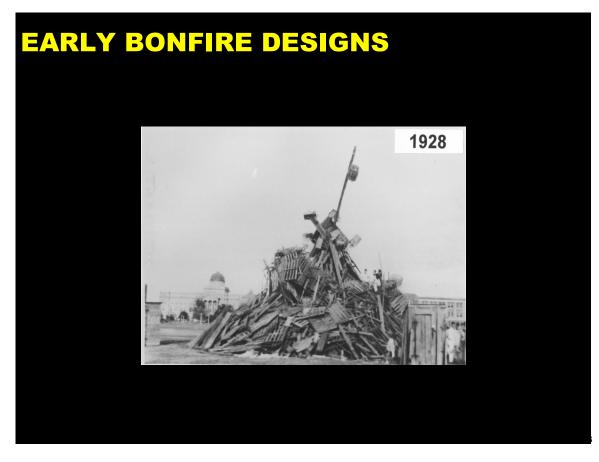
Early Bonfires were not nearly as large or complex as they are now. They were nothing more than piles of wood and trash, as you can see from this 1928 photo. Complexity increased over time, however, with students adding features and increasing the size almost every year.

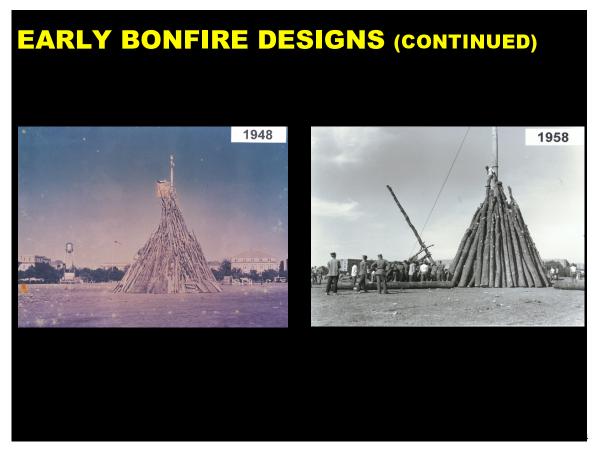
The mid 1940s saw the introduction of center poles and a teepee-shaped design, both of which can be clearly seen in photos of the 1948 and 1958 stacks.

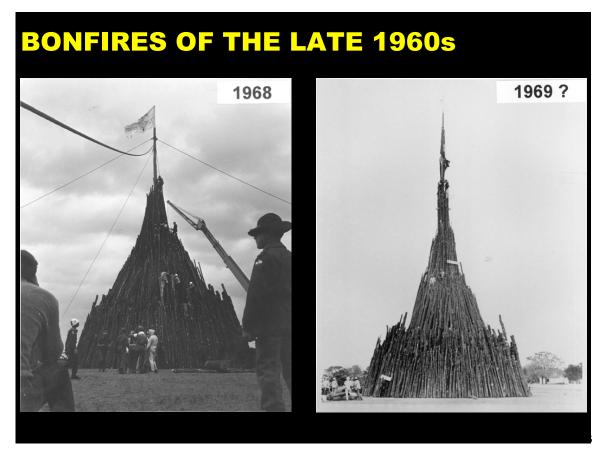
Because a pure teepee-like Bonfire can only be built as high as the tallest log, multiple layers of logs were introduced by the 1960s, allowing the construction of much taller Bonfires. Both the 1968 and 1969 stacks utilized this multi-tier design, with the 1969 stack reaching 109 feet – the tallest Bonfire ever recorded.

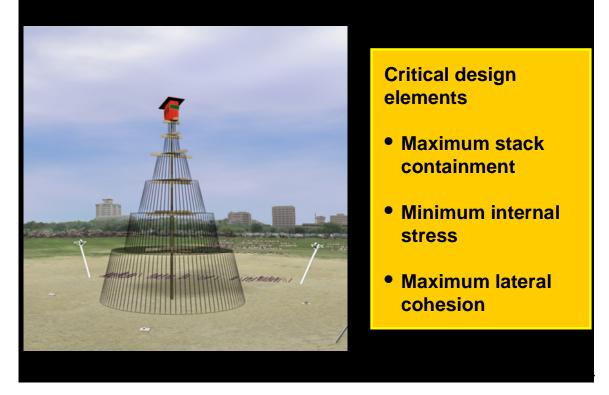
## **COMPOSITE BONFIRE DESIGN**

This stack has all the standard features of the 1980s and 1990s – wedding cake design, six tiers, etc. When Team 1 modeled and examined this composite design, it became apparent that there were several design elements particularly important to structural integrity. It is critical to ensure that these elements, listed here in approximate order of importance, are handled properly from year to year:

- 1. **Maximum stack containment** requiring the use of strong wires and cables
- 2. **Minimum internal stress** requiring minimal use of wedging, symmetrical build-out of each stack, and lower stacks that are much wider than the stacks above them.<sup>1</sup>
- 3. **Maximum lateral cohesion** requiring extending or interlacing lower stack logs into upper stacks.

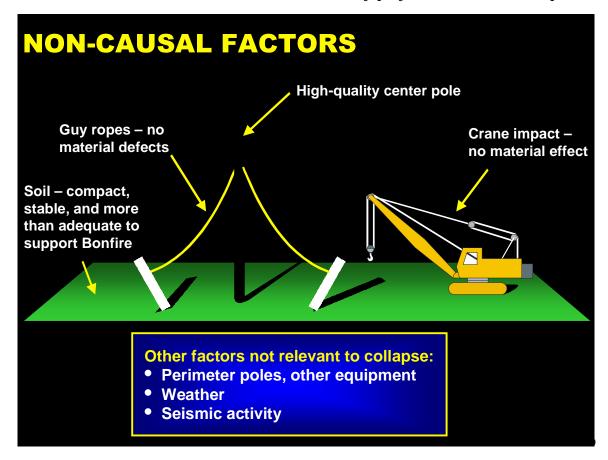
- 1. **Center pole** Team 3 examined strength and wood quality, checked for weakness due to fungus or decomposition, examined breaks and cracks, and examined the splice. The center pole passed all tests comfortably. It is also important to note that given the enormous weight of the stack, even a perfect center pole could not have played a significant role in providing structural strength.

- 2. **Soil** Analysis showed the soil to be sufficiently compact and stable and that it could easily support a structure at least twice as heavy.
- 3. **Guy ropes** All ropes tested were of good quality, with no material defects found. Although one of the guy ropes did fail during the collapse, it was not a contributing factor because it broke after the collapse sequence had started.

- 4. **Crane impact** Interviews and evidence indicate that a few days before the collapse, a crane struck and broke off a small piece of a cross tie attached to the center pole. As a test, Team 3 modeled the maximum force that such an impact could have generated. Team 3 determined conclusively that the impact of the crane could not have materially affected the center pole or contributed to the collapse.

5. **Other factors** - Lastly, it was determined that there were no defects in the perimeter poles or other equipment that could have contributed to the collapse. Also, no material evidence was found that any external factor such as weather or seismic activity played a role in the collapse.
